TECHNICAL NOTE

Filing Code 1525 (P-401) no.32

Bureau of Land Management U.S. DEPARTMENT OF THE INTERIOR

CHEVROLET VEHICLES EQUIPPED WITH ROCHESTER CARBURETORS

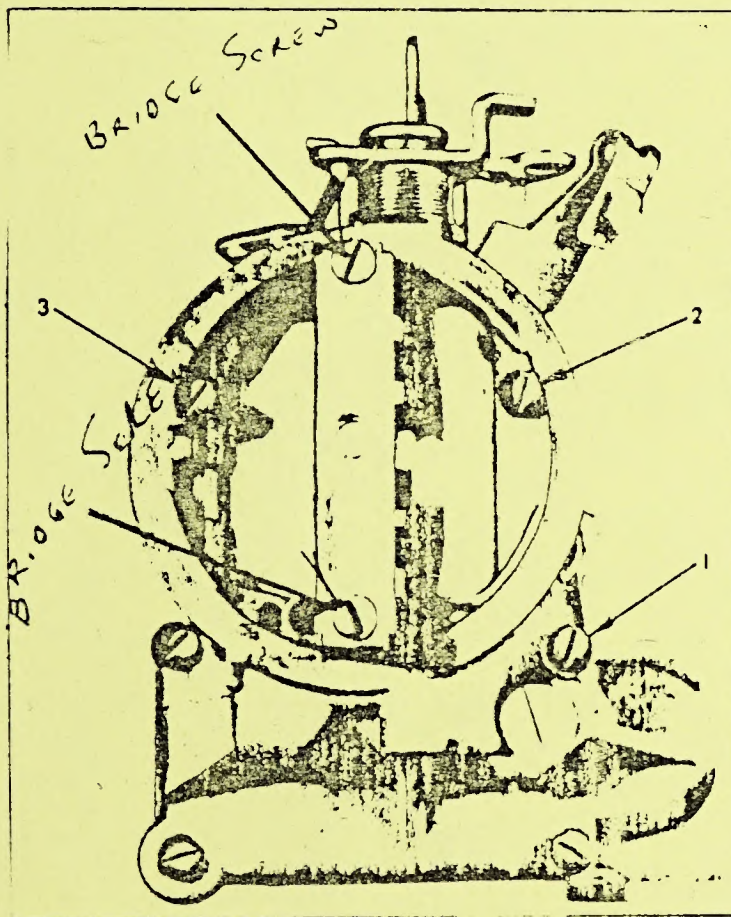
We have been advised that several 1968 and 1969 Chevrolet engines equipped with a Rochester Monojet Carburetor have been damaged, due to air cleaner stud bracket screws vibrating loose and dropping into the combustion chamber. This has caused broken cylinder heads, pistons, and cylinder wall damage.

To correct the problem, remove the bracket screws and place an internal Star Lock Washer, Size No. 10, under each screw and tighten securely.
